# SERVICE AND APPLICATION NOTES

December 16, 2013  
Revised April 16, 2015

## ECB25-10KW Electric Heat Section Wiring Error

ECB25-10kW electric heat section installed in a CBX25UH and CBX25UHV air handler units.

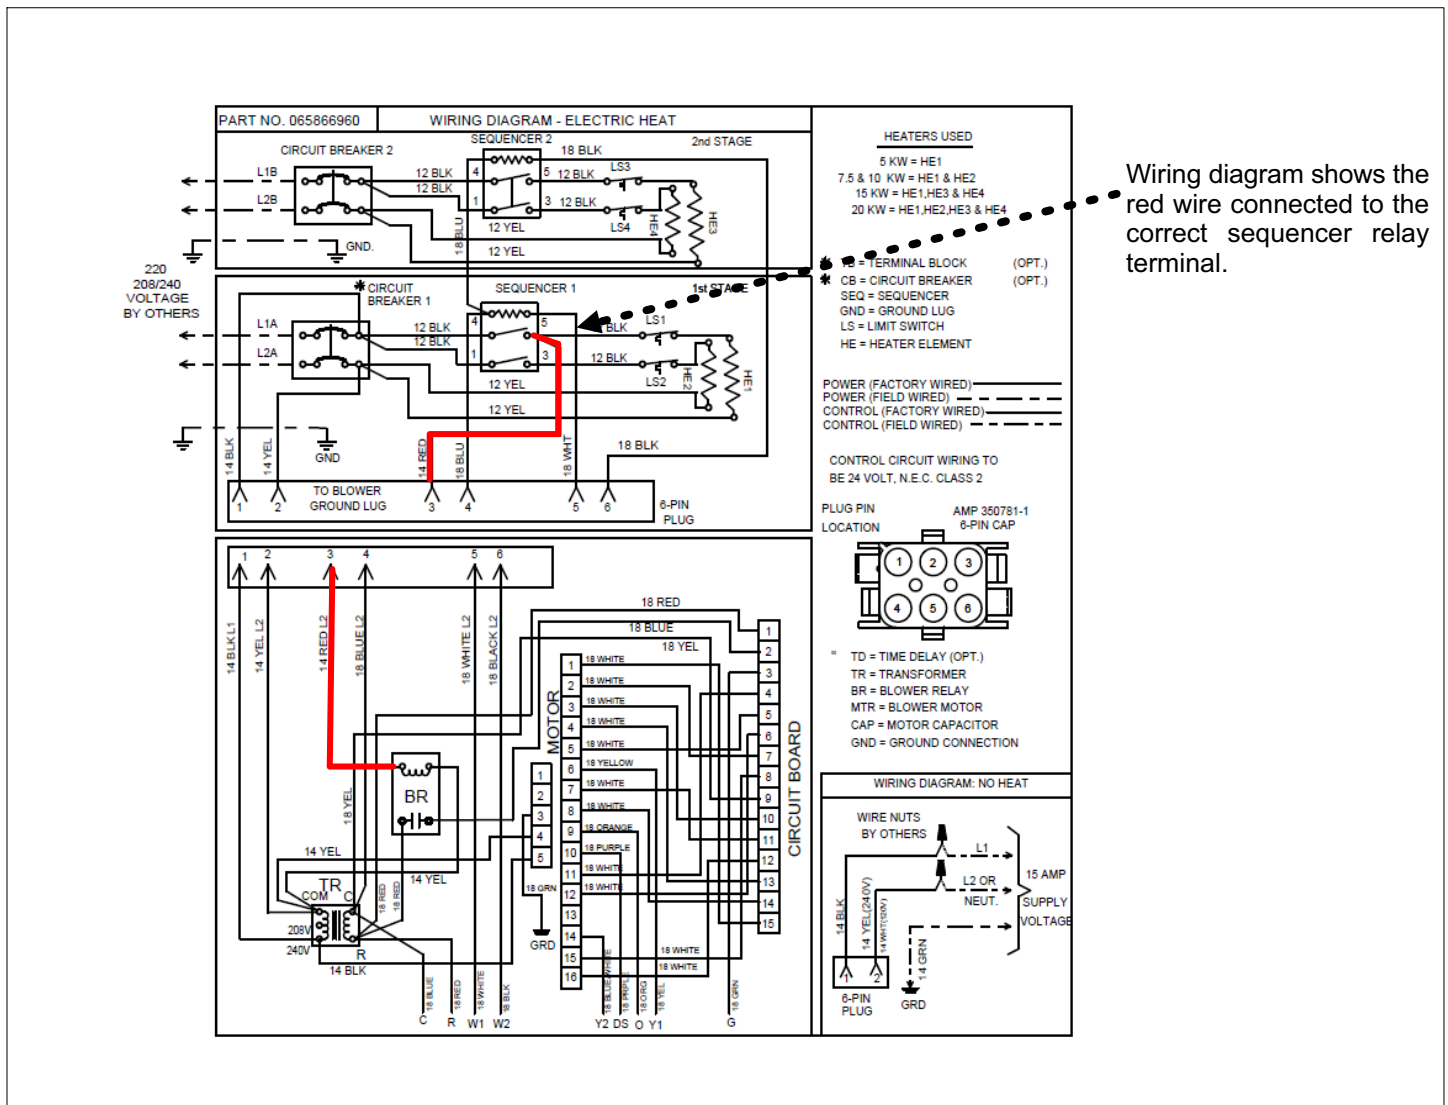
Figure 1. Correct Connection to Sequencer Relay Terminal

Wiring diagram shows the red wire connected to the correct sequencer relay terminal.

1. Red wire in electric heater section that provides power to the indoor blower motor during a heating call is on the line side of the sequencer relay terminal. The red wire needs to be placed on the load side of the sequencer relay terminal as shown in figure 1.
2. The black and yellow main power wires are reversed in the 6-pin plug (see figure 3). The yellow and black wires need to be reversed (see figure 4).

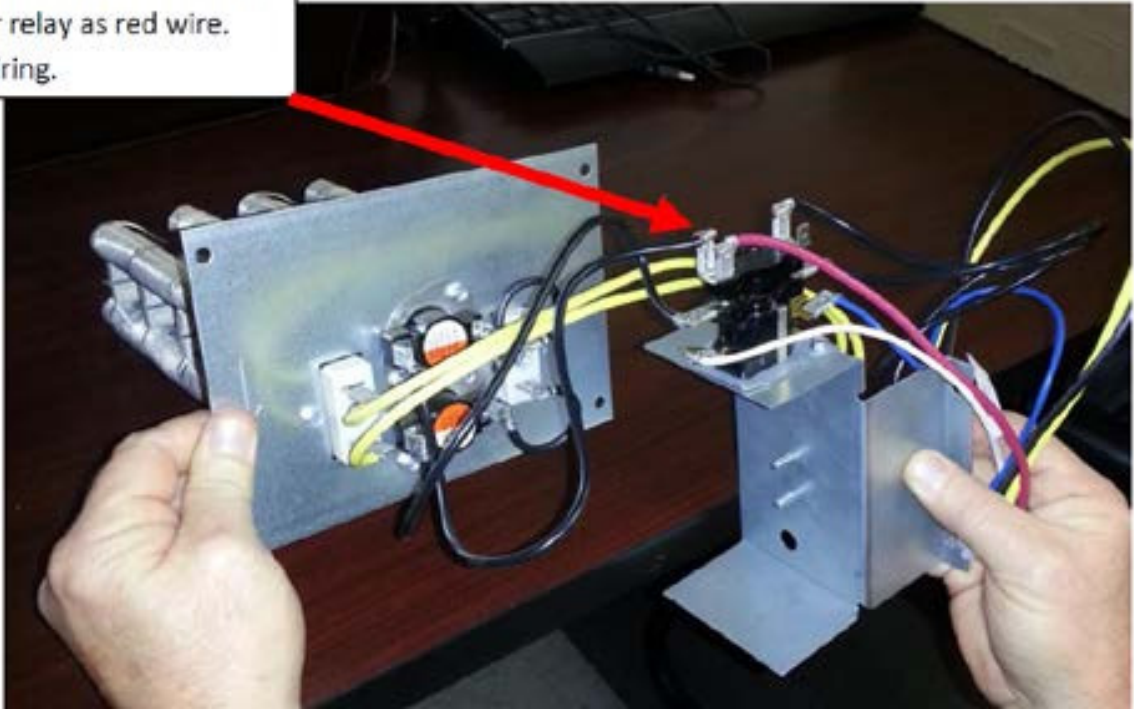
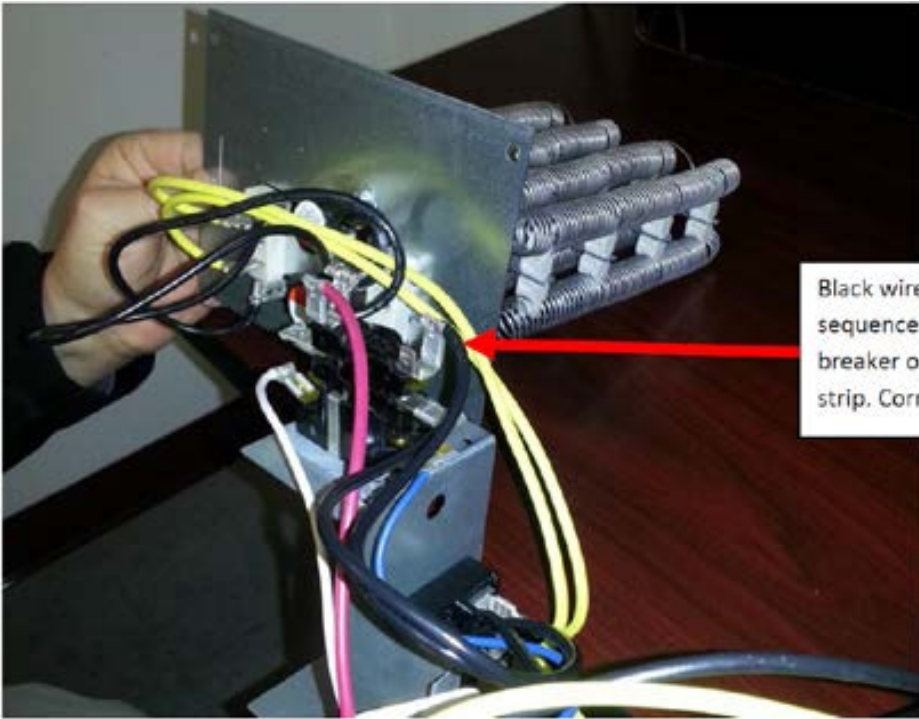
Figure 2. Wiring Location

Black wire from electric heater element on same terminal of sequencer relay as red wire. Correct wiring.

Black wire on the other side of the sequencer relay goes to circuit breaker or main power terminal strip. Correct wiring.

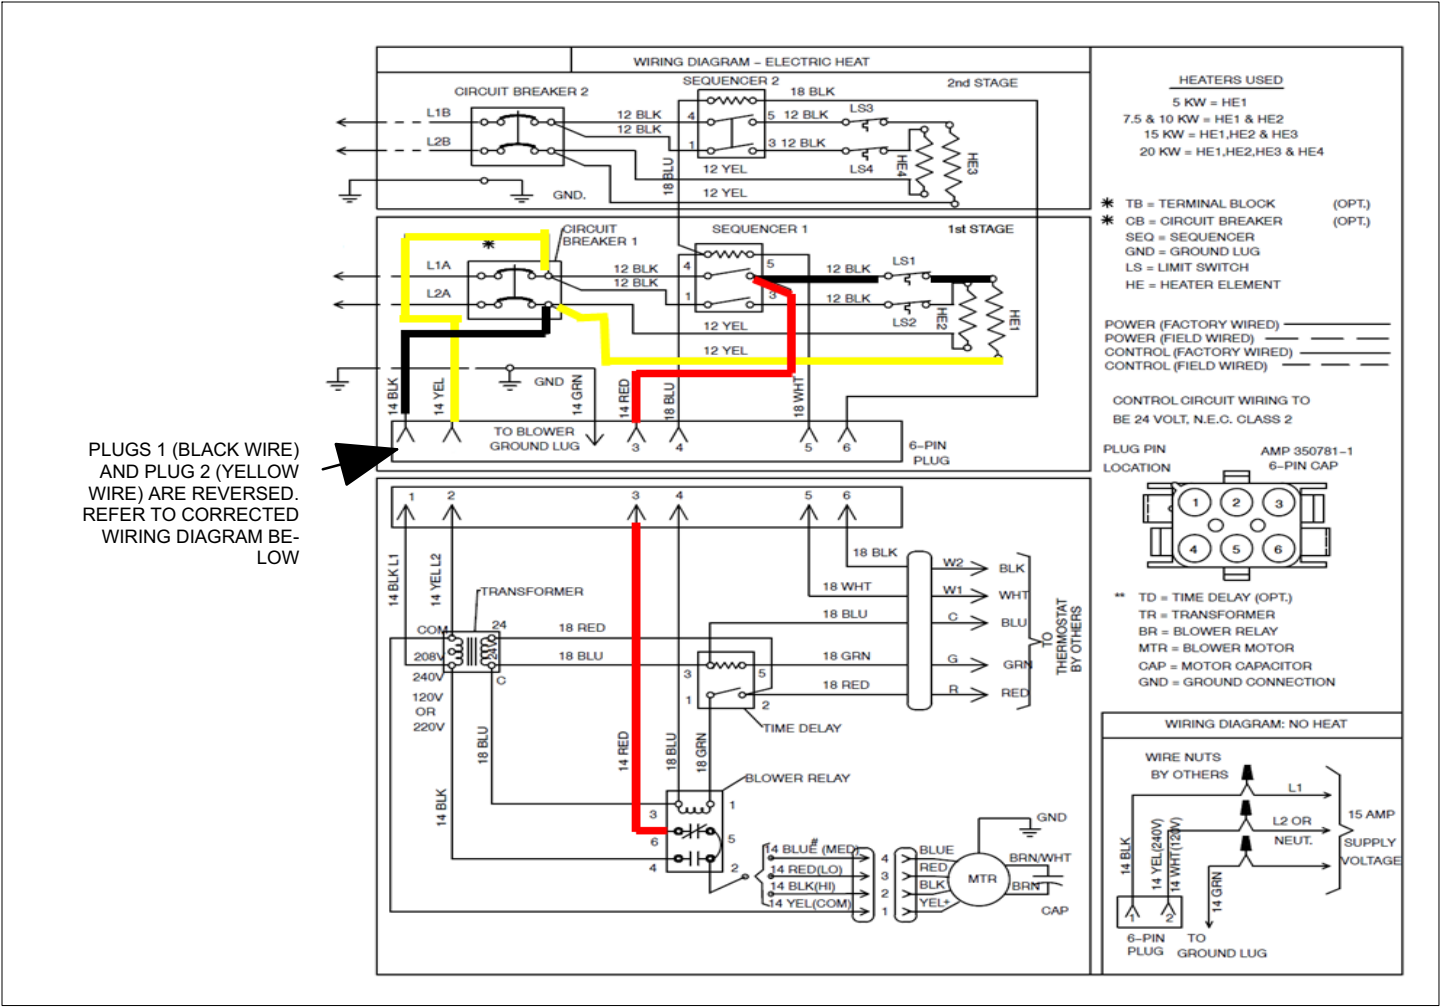
**Figure 3. Shows Incorrect Wiring of Yellow and Black Wires in 6-Pin Plug**

Field reports of indoor fan motors being energized as soon as main power is applied to unit.
