DEALER SERVICE BULLETIN

Number: DSB 14-0015

Title: Variable Speed Inverter/AOC Board Rework

Bryant: 189BNV, 288BNV
Carrier: 24VNA9, 25VNA8

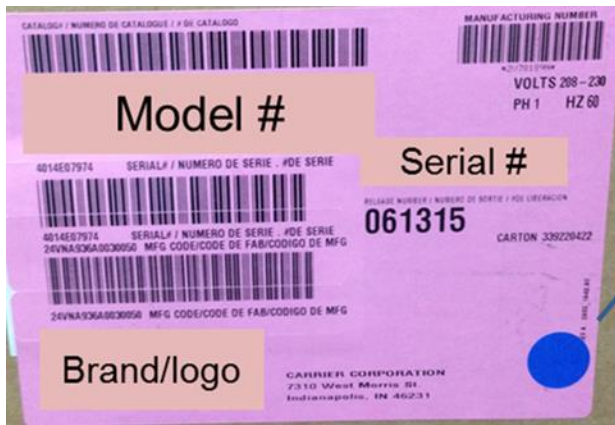
Blue Dot Signifies that unit has been reworked at the factory

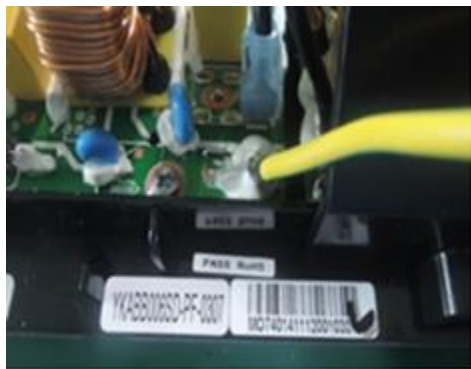
Replacement Components has placed inverters only on Quality Hold for rework. Inverters with AOC boards with the correct operating software will have a black checkmark on the serial number rating plate located on the inverter rail and a blue dot placed on inverter box label.

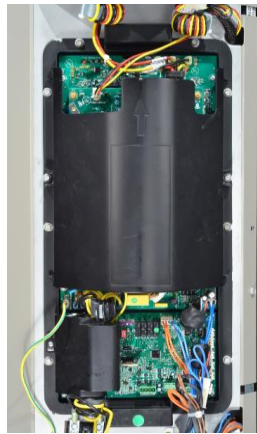
3. AOC board is located at the bottom of the inverter. The inverter cover does not need to be removed to remove and replace the AOC board.
