**To: Residential Distributors and Dealers**  
**Aftermarket Distributors and Dealers**  
**From: Technical Support**  
**Date: October 28, 2014**  
**Re: Inducer Wheel Failure**

Subject: 90 % Efficiency Inducers with potential cracks in the hub area of the impeller.

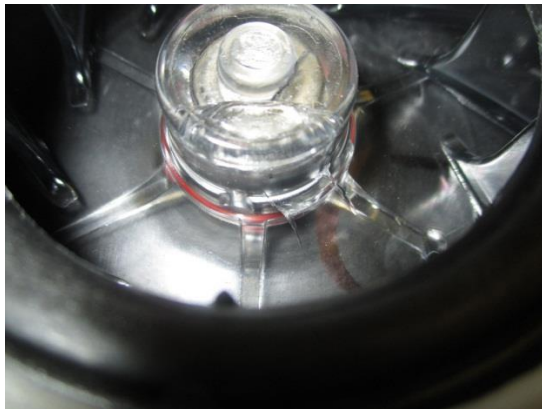
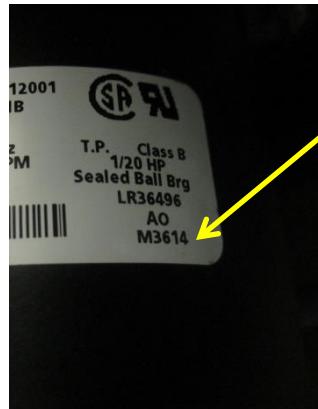
*Inducers with a motor date code of M3614 on the label are affected*

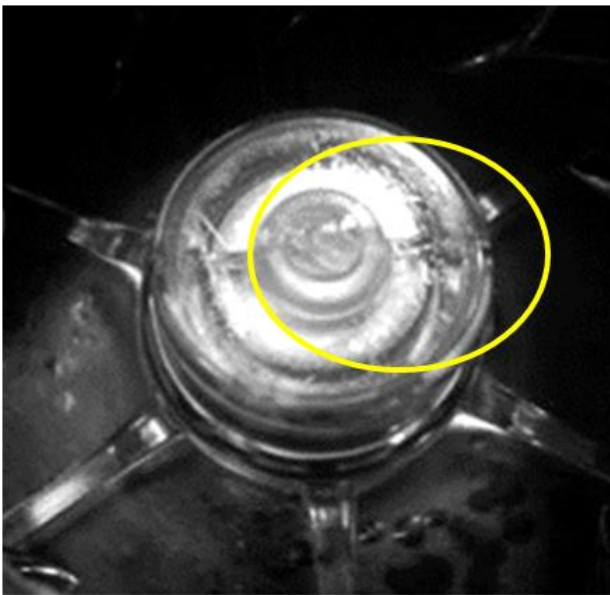
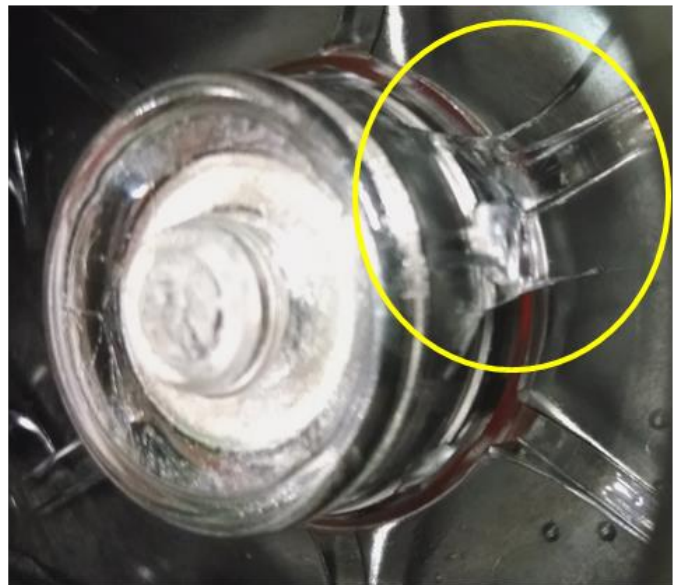
Figures 1 & 2: Hub crack examples

This letter is to notify you of a potential issue affecting limited production of Fasco part number 702112001 (Nordyne part 622302). The issue is a crack in the impeller and is present only in the hub area as indicated in the figures one and two.

The root cause has been identified and corrected, and is isolated to the part noted above. Preventive actions have been implemented as of Oct 8<sup>th</sup> 2014.

Whether this issue will cause a product failure in operation is undetermined at this time; however, Fasco takes the quality of its products seriously. We would like to alert the customer to look for the cracked impeller as shown.

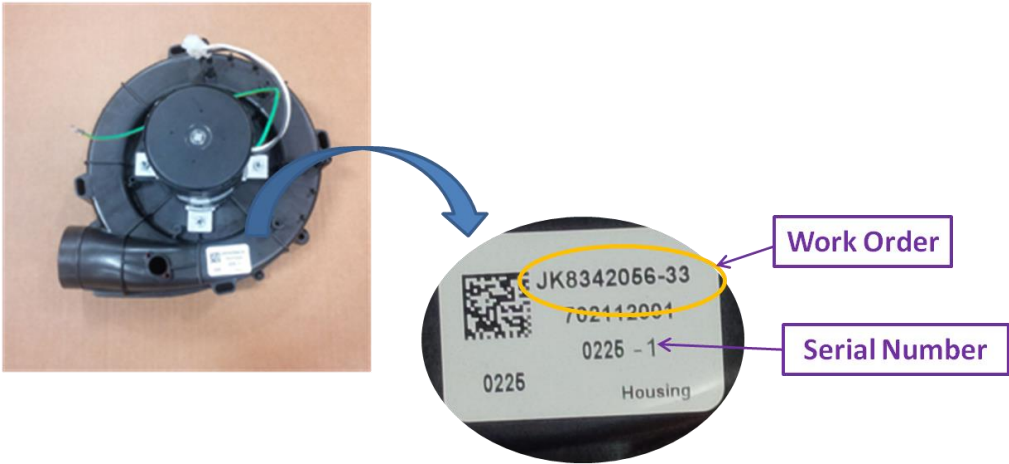
Figures 4 & 5: Location of Fasco work order number

The Fasco internal work order number is printed on a label for each blower, shown below in figures four and five.
