# DEALER SERVICE BULLETIN

**Number:** DSB 12-0019b

**Title: Regal Beloit X-13 Blower Motor DOA  
Failure**

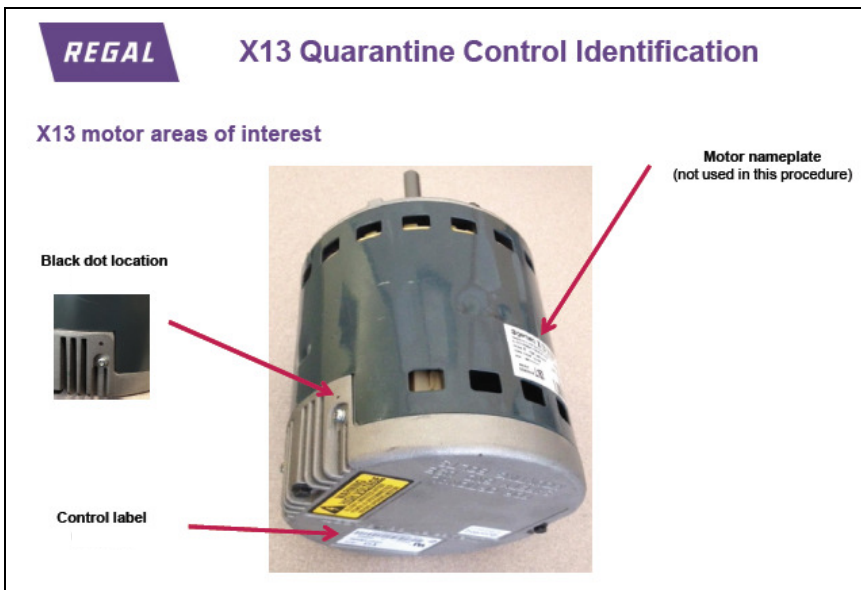
## X13 Quarantine Control Identification

### Good Control

(if any one of these items is present)

1. 115VAC or 460VAC\*
2. 1HP (any voltage)\*
3. Black dot on the control in this location.
4. Six digit serial beginning with "C" (circled below)\*
5. Control date OUTSIDE range 3/5/2012 to 4/20/2012 (circled below)\*

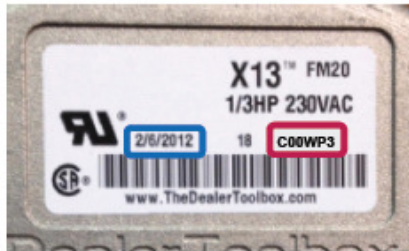
### Suspect Control

(all of these items must be present)

1. 230VAC\*
2. 1/3HP, 1/2HP, or 3/4HP\*
3. No black dot on the control in this location.
4. Six digit serial beginning with "00" (circled below)\*
5. Control date from 3/5/2012 to 4/20/2012 (circled below)\*
6. Is control serial number on suspect list?
