General Service Bulletin

Foil Delamination

Models: *UD100R9V5K, *UD2C100ACV52A

ORDER No: **FURN-SVB49A-EN** DATE: **January 23, 2013**

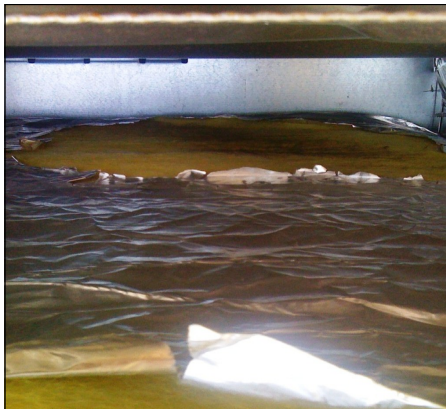
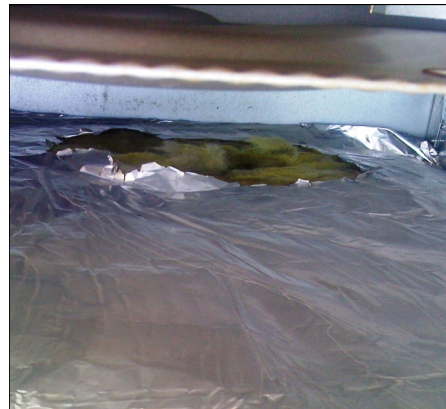
- There is potential for the foil to delaminate and blow into the coil which can restrict air flow and block condensate.
- The action described in this bulletin should only be taken on units that experience foil delamination failures.
- *This is a "Fix on Fail" action.* The action described in this bulletin should only be taken on units that experience condensate leakage.
- The action described in this bulletin is not being taken to address a safety concern.

Foil delamination is most often caused by high static / high air velocity conditions. The air side design using a 21 inch wide furnace with a 5-ton blower can be challenging. Evaluate the ductwork along with coil & filter selection to ensure a proper air side design. Total external static pressure inside the furnace cabinet should not exceed 0.85 inches of static.

- Inspect the inner walls of the burner cabinet or the entering air side of the cooling coil for foil delamination. Foil trapped in the cooling coil will often become evident by poor system performance
- If foil break down is found; remove the foil from the coil and all air side components in the system
- Check total system static pressure with the return static reading at the furnace blower and the supply static reading between the blower and coil
- Air side modifications (coil / filter selection and duct system) must be modified if total external static exceeds 0.85 inches of static
- If foil delamination is found, install **KIT16433** to secure the insulation and ensure the coil and air side system is clean
