IMPORTANT PARTS-SERVICE COMMUNICATION

**NO:** GF-129

**SUBJECT:** Auxiliary Limit Mounting Clip used on GUIC Model Furnaces

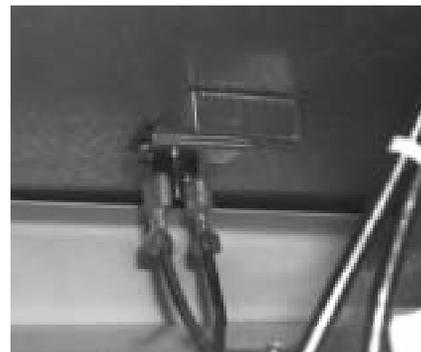
Amana is instituting a mandatory rework of all GUIC model furnaces manufactured between July 13 and August 7, 1995 serial numbers 9507133880 through 9508174322. These furnaces may have an improperly manufactured **Bracket-Auxiliary Deck Limit** part number **10861101**. This part was improperly manufactured by the supplier causing it to be brittle. In some cases the bracket may break which could result in the secondary limit moving out of position in the blower deck and become inoperative. The terminal connections at the limit are insulated and are part of the 24VAC low voltage circuit so no shock hazard exists.

1. Disconnect power supply (if installed).
2. Remove access and blower compartment doors.
3. From underside of blower deck, grasp the Bracket-Auxiliary Limit, and pull forward to remove.
4. To install the new bracket, hold the limit in position, align tab on new bracket with slot in blower deck, push bracket towards blower housing until seated.
5. Replace doors and test furnace operation (if installed).
