## TECHNICAL SERVICE BULLETIN

### TB08-102 R-M

**TO: NORDYNE DISTRIBUTORS  
NORDYNE DEALERS**  
**FROM: TECHNICAL SERVICE DEPARTMENT**  
**DATE: February 11, 2008**  
**RE: Chattering Check Valve on the GB5BW Air Handlers**

## 632392R - Magnet Kit GB5BW

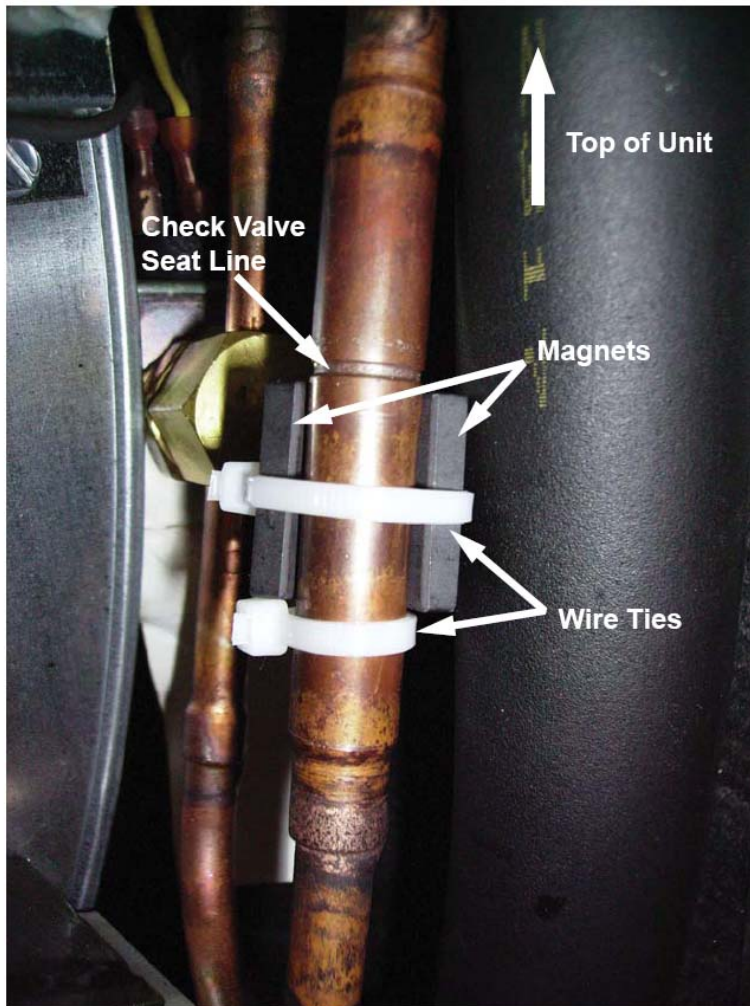
Locate the magnets as shown with the top of each magnet at or slightly below the check valve seat mark on the check valve body.

The top wire tie serves to hold the magnets against the check valve body.

The bottom wire tie can be replaced by tar tape or any other means of preventing the magnets from slipping down the in the check valve.

In the interim Nordyne recommends that a magnet kit (632392R) should be use to correct the noise issue. Attached are the Installation Instructions for the magnet kit.
